Final Environmental Assessment

**Franklin D. Roosevelt
Presidential Library and Museum
Renovation Project
Hyde Park, New York**

April 2010

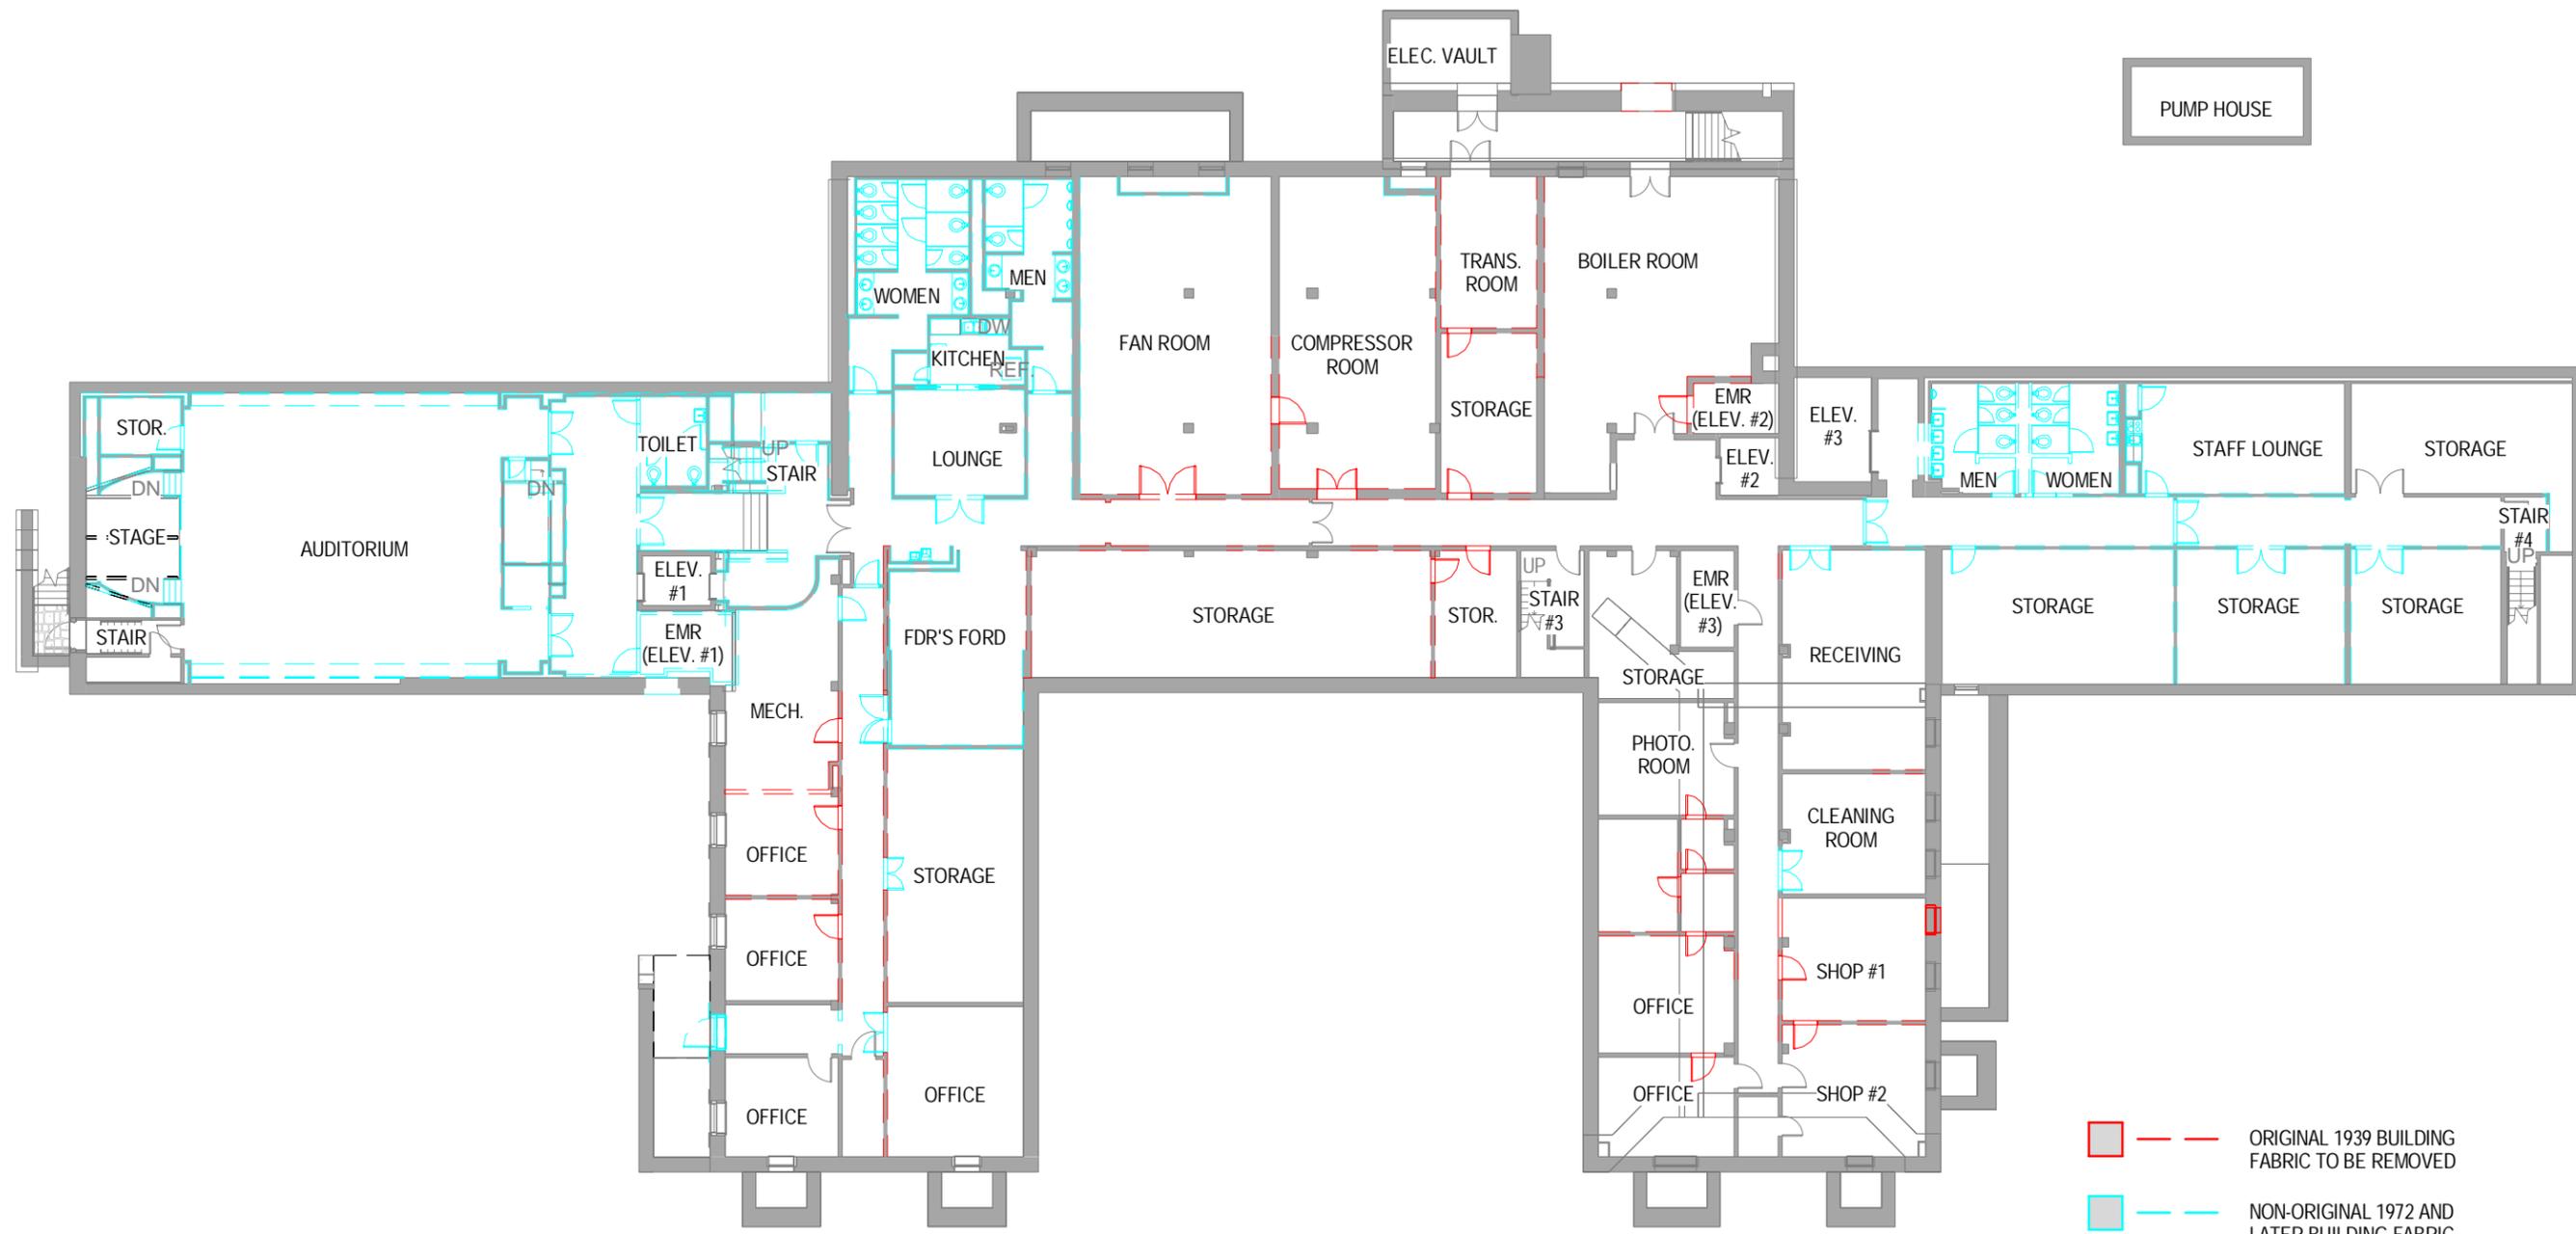
— ORIGINAL 1939 BUILDING FABRIC TO BE REMOVED
— NON-ORIGINAL 1972 AND LATER BUILDING FABRIC TO BE REMOVED

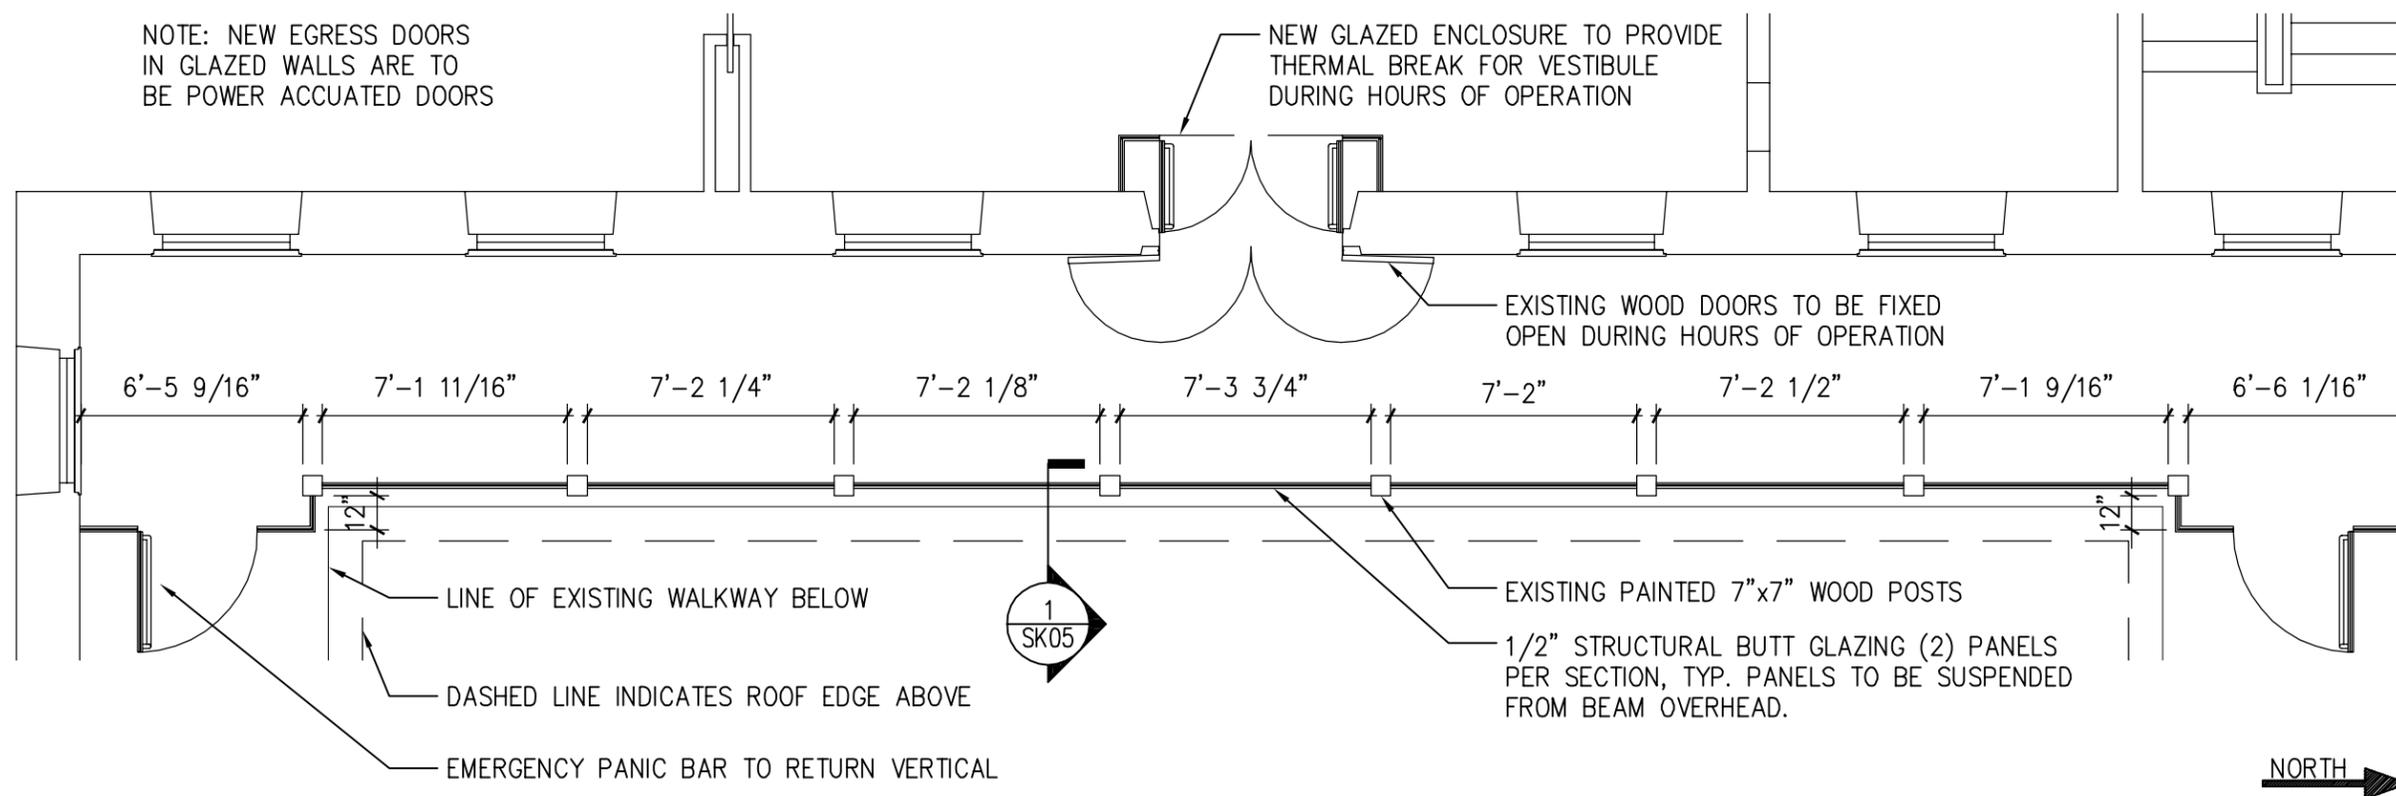
1. ENLARGED PLAN

2. EXTERIOR COURTYARD ELEVATION

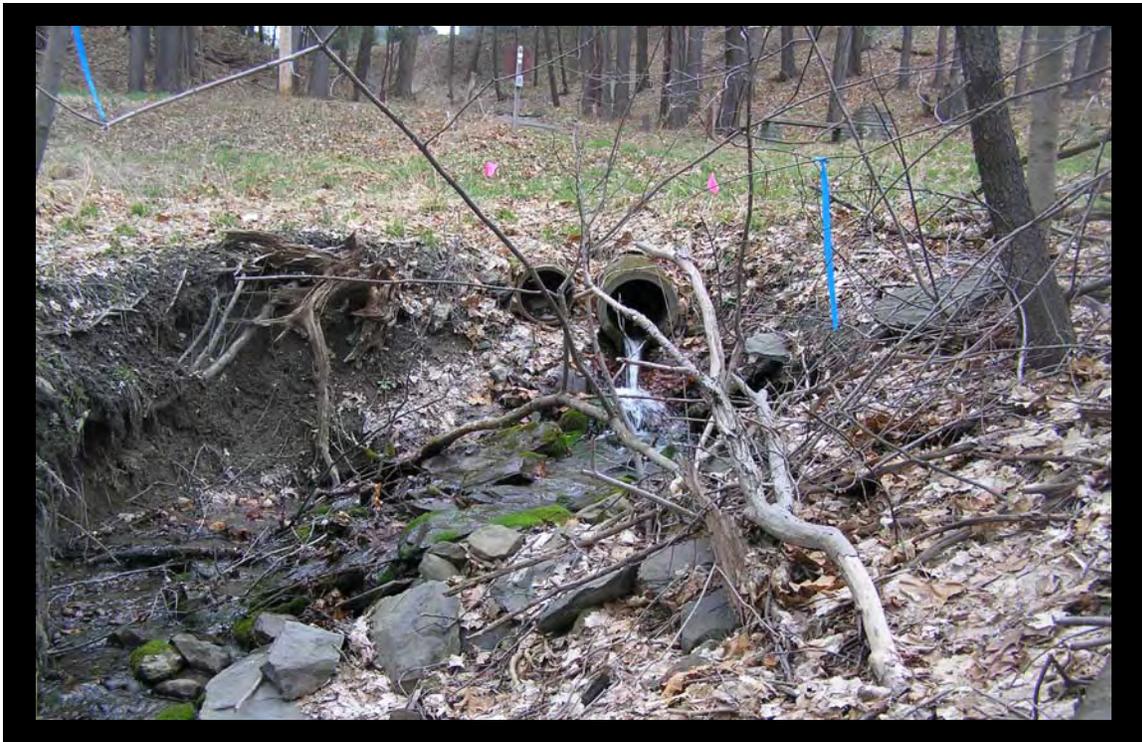
Photo 6 – Stormwater spillway.

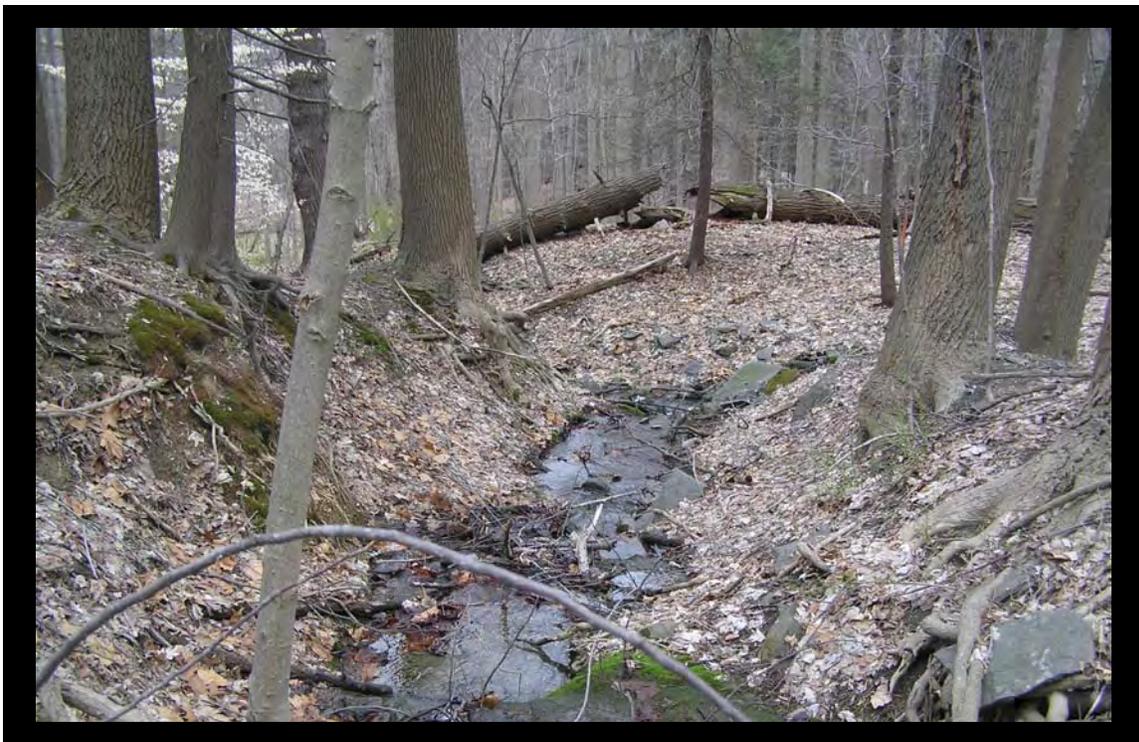
Photo 10 – Spillway channel looking west.

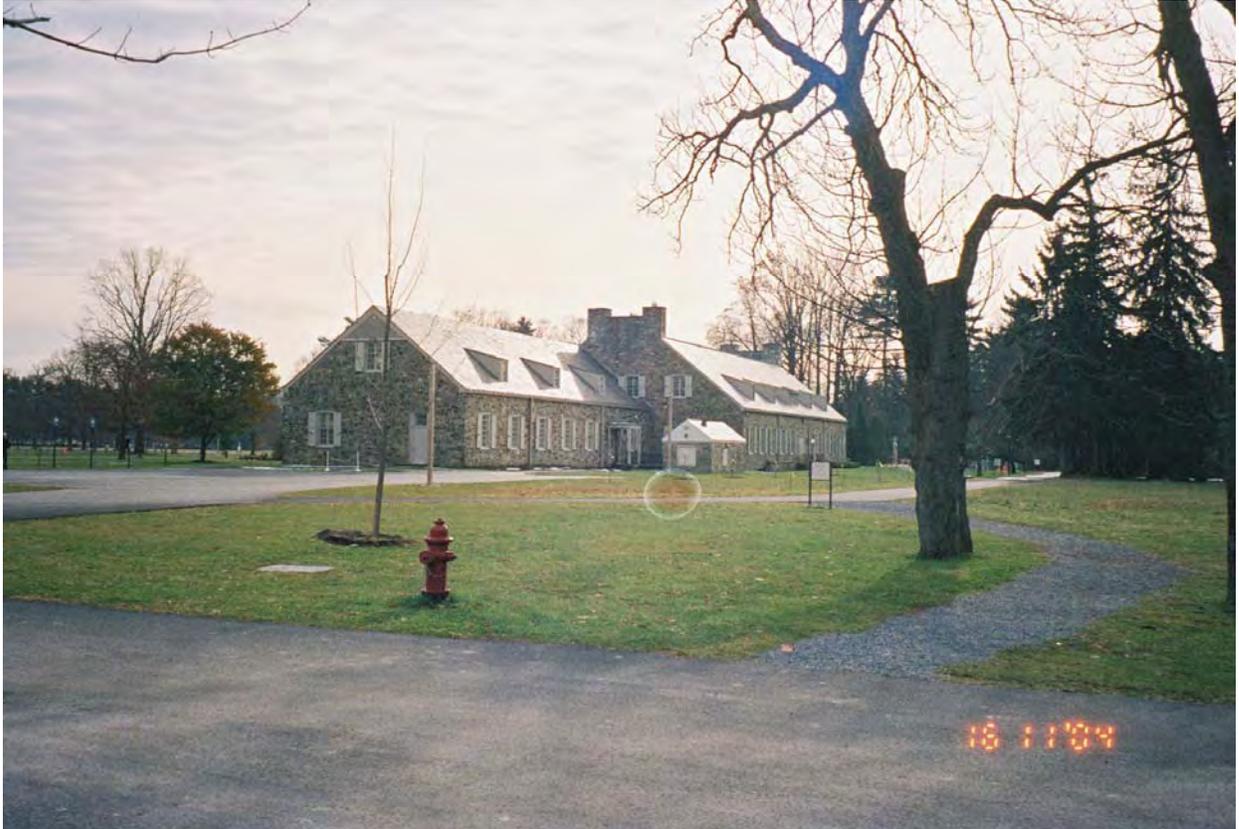
**View of Existing Loading Dock
Looking Southeast from Visitor's Center Parking Lot**

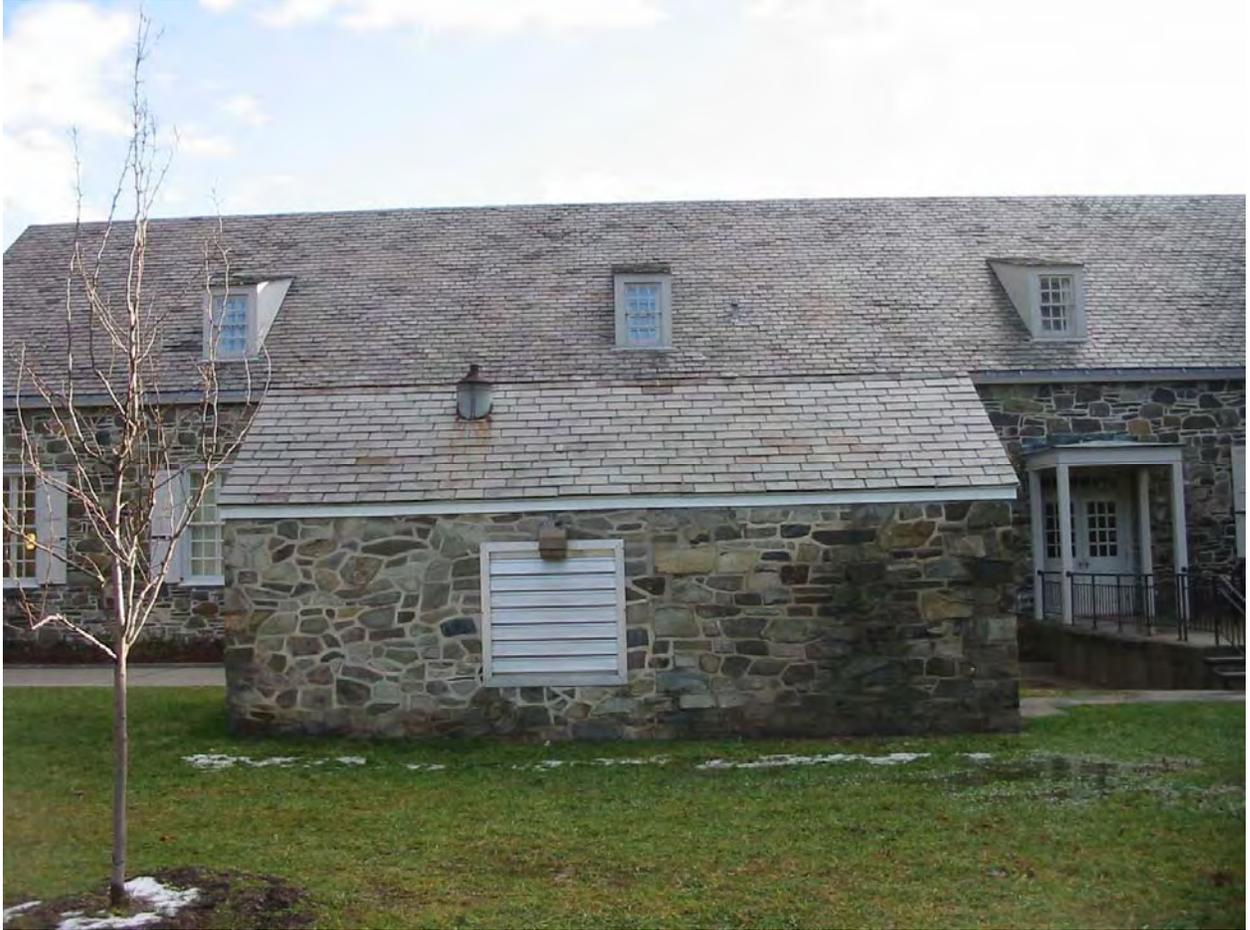
**View of Pump House and Existing Loading Dock
West Elevation**

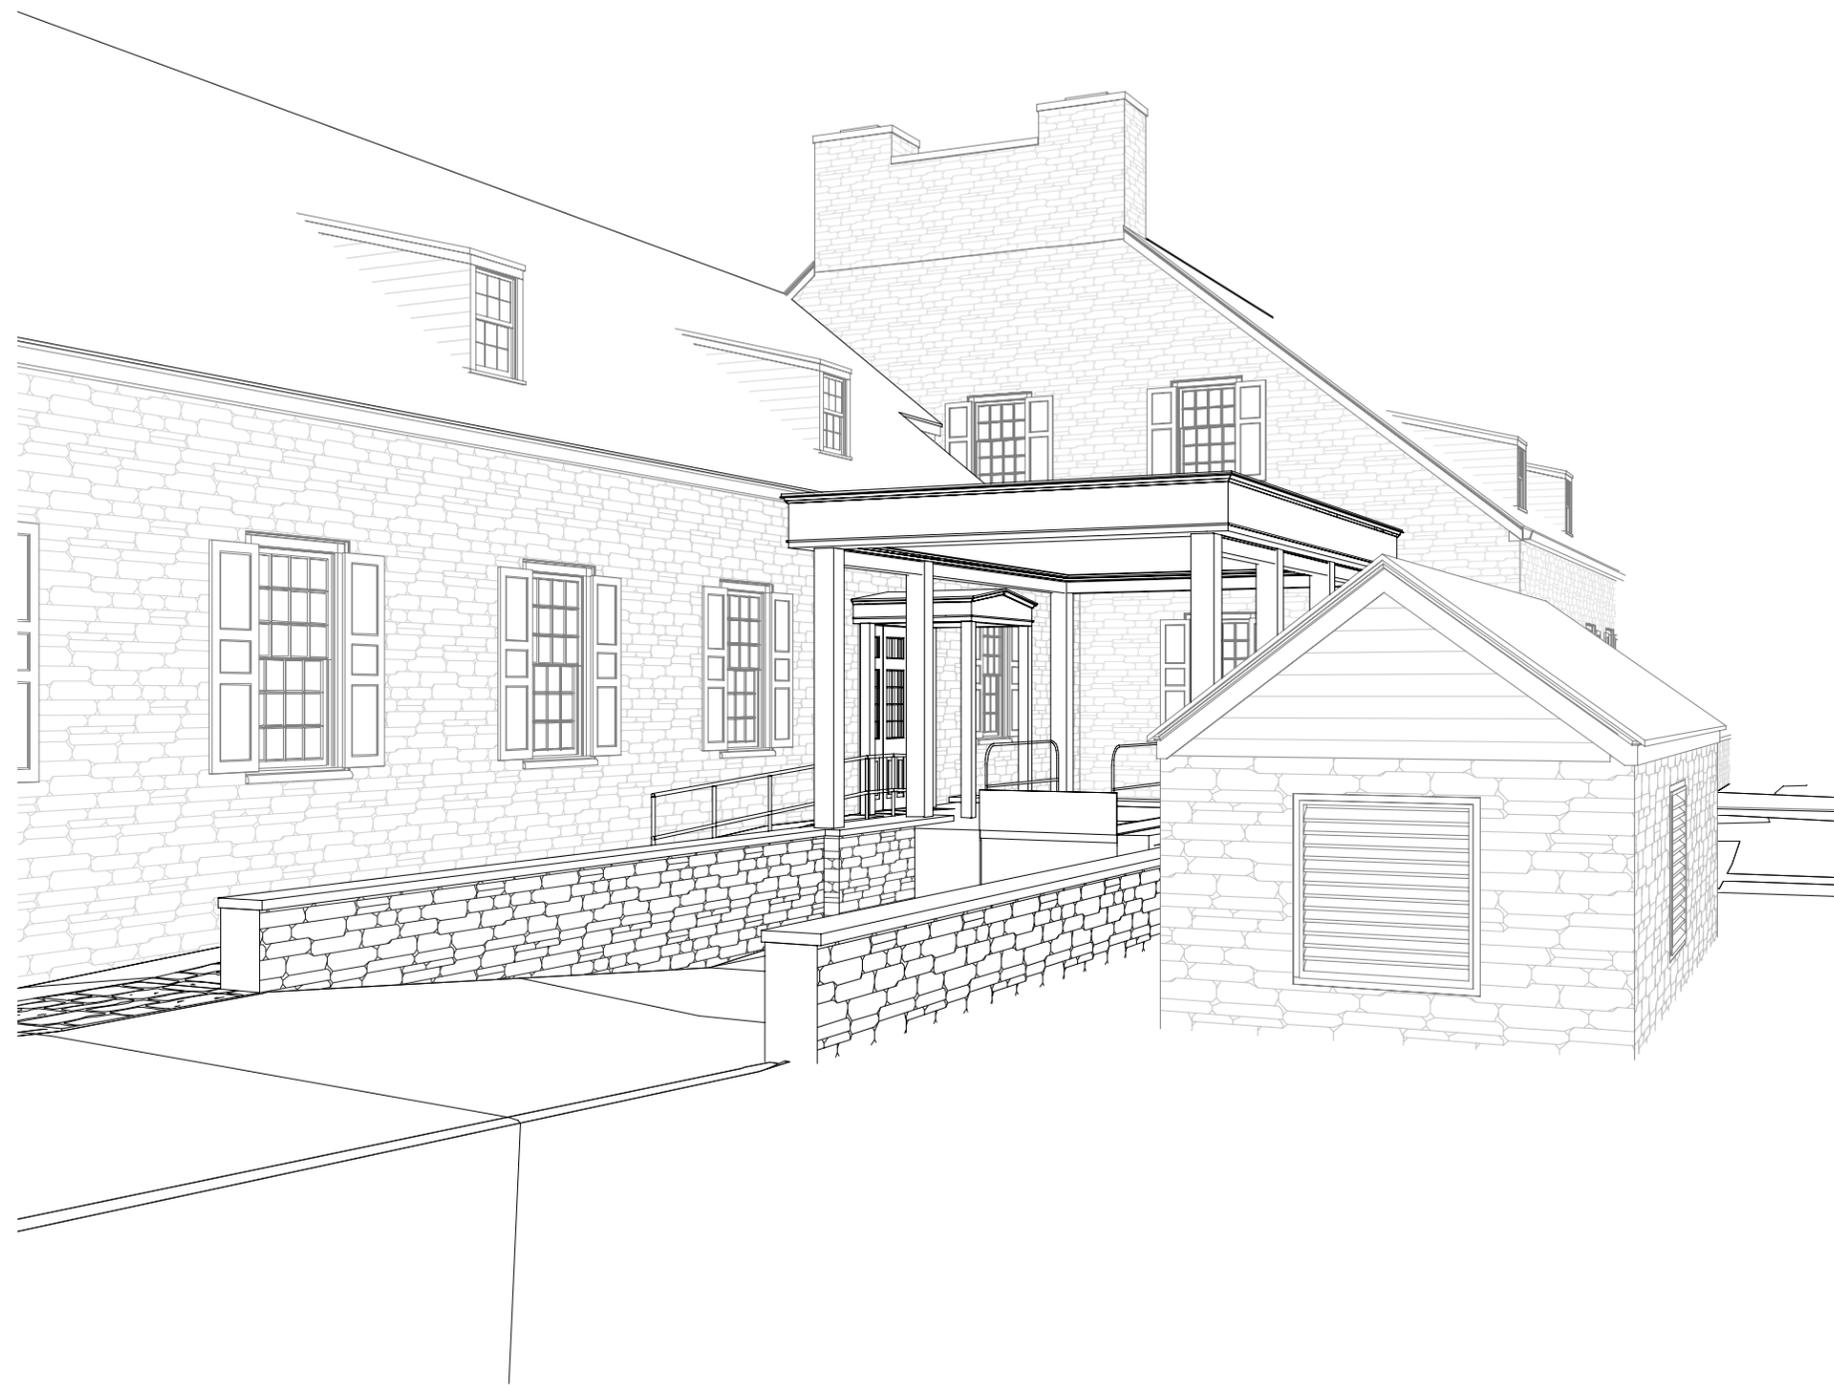
**Perspective of Proposed Loading Dock Revisions
(Current)**

- Add airlock space enclosure under porch to achieve National Archives standards for climate control of museum galleries and archives.
- Enlarge loading dock and loading dock canopy and modify ramp to existing loading dock to accommodate delivery of crates of art and historic artifacts for the museum's changing exhibit program. (No change to original 1939 building.)
- Basement level emergency exit on east elevation of 1972 wing. (No change to original 1939 building.)

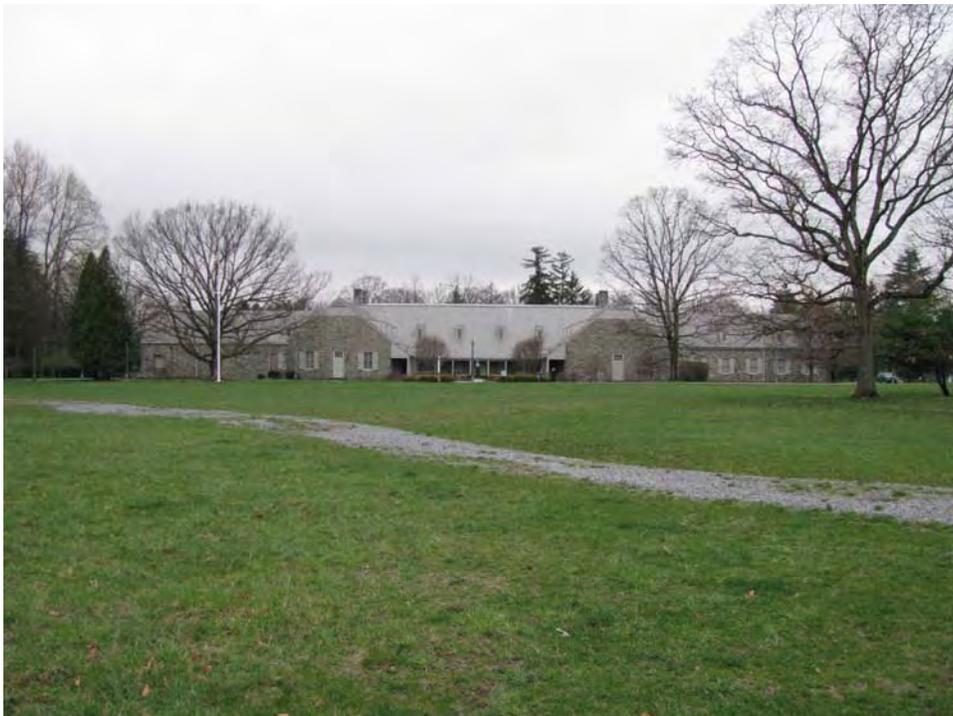
Photo 2. View of library building looking west-southwest, showing relatively level ground surface.

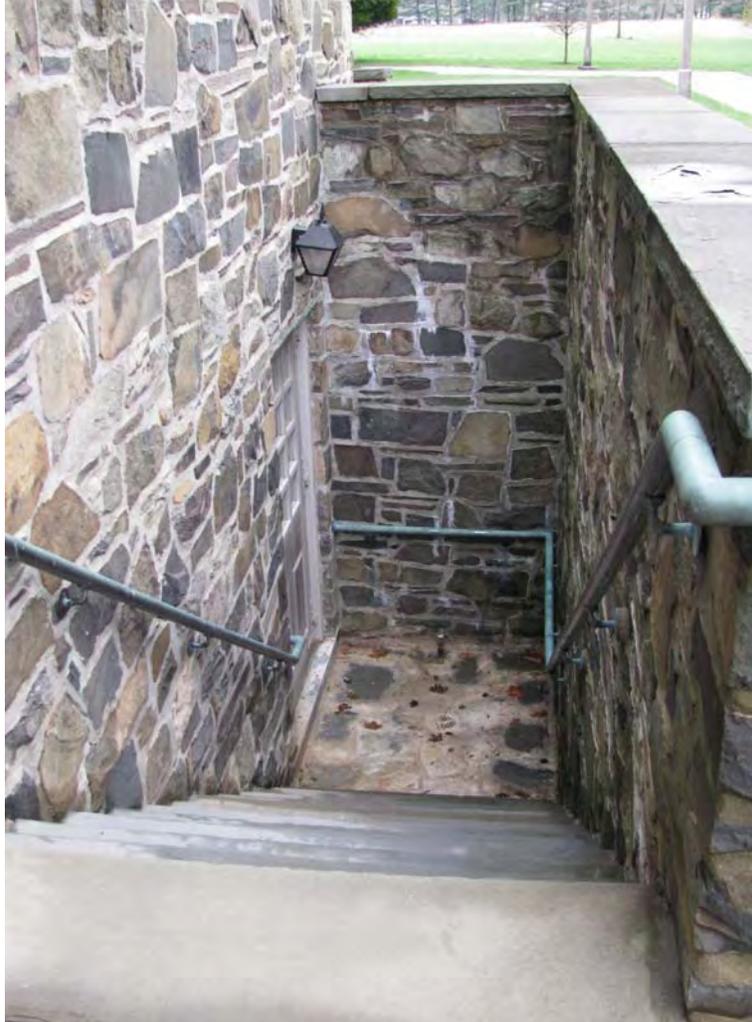
Photo 3. Stair to basement entrance, showing the depth of disturbance required for building the foundation of the south wing, looking east.

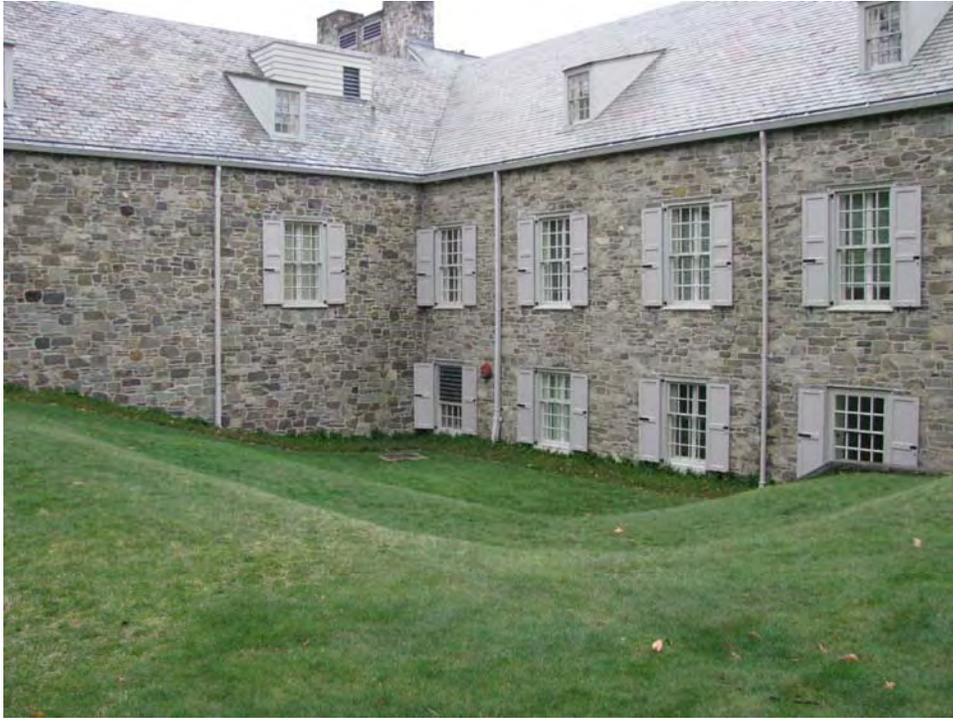
Photo 4. View of two-tiered depression with a catchment basin, looking northwest. It is located on the east side of the building where the south wing connects to the main library building.

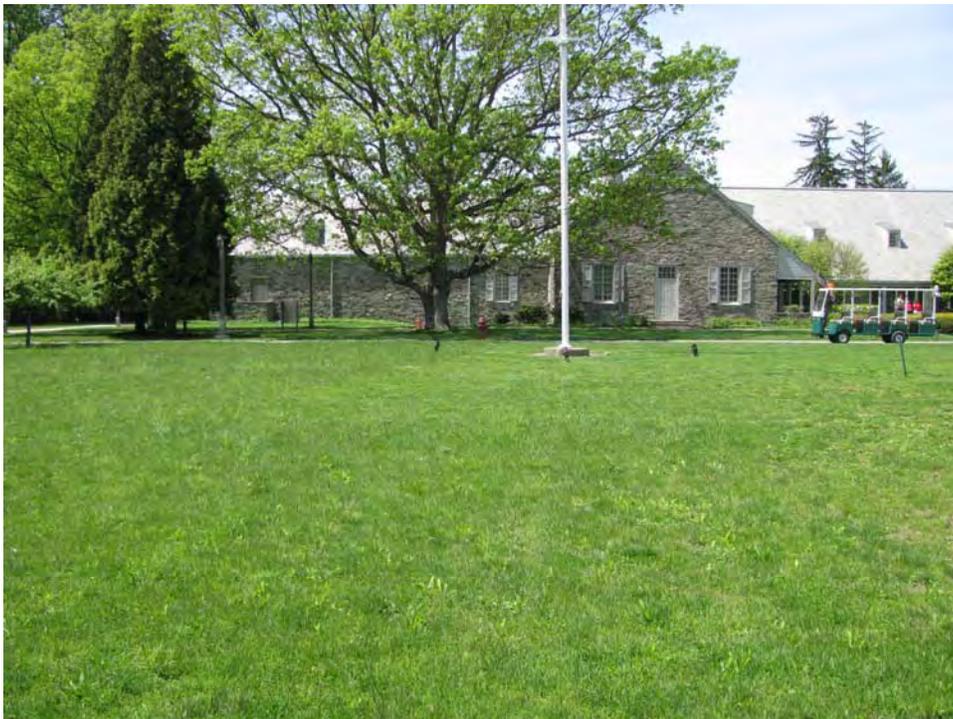
Photo 5. View of mature oak tree east of the south wing of the library, looking west.

Photo 5. View of mature oak tree east of the south wing of the library, looking west.

A second cluster of tests was excavated off of the northeast corner of the library in the front lawn (Photo 5). New water lines for fire suppression, a storm water drainage system, and heating and cooling pipes are proposed in this area. Currently, this portion of the project area is criss-crossed with existing buried utilities including water lines, sewer lines, cable and telephone lines, and electrical lines for lighting along with associated concrete vaults. Also, according to the as-built plans this area in the northeast corner of the library was originally the visitor's parking area. The parking area was subsequently removed and several manifestations of pedestrian trails were built and removed over time.

Tests in this area included 106 to 110, 116, 118, and 119. Of these tests 106 to 109 appear to be along the same alignment of the former access road, as evidenced by a row of mature trees to the east (Photo 5). All of these tests terminated onto compacted soil and gravel that appeared to be a road surface located 17 to 33 cm below the ground surface. None of these tests located artifacts. Similarly, test 110 was terminated at 50 cm in fill with a large rock obstruction. Test 116 and 118 ended at about 60 cm due to compacted soil. Test 199 stopped on top of asphalt that appeared to be part of a former sidewalk.

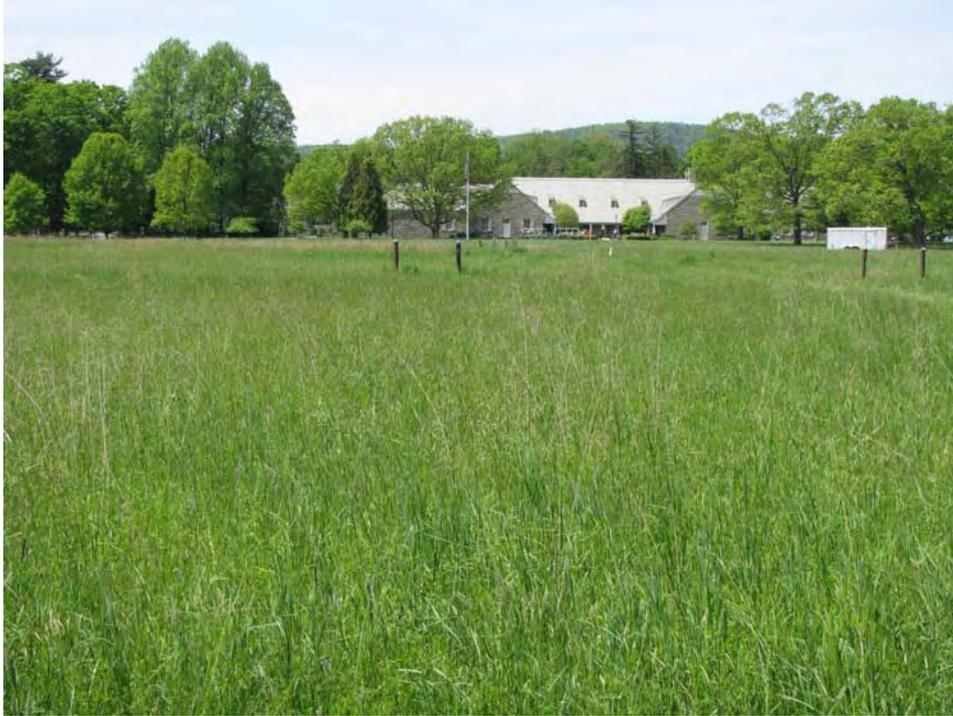
Photo 6. View of field looking west toward the library, showing mature oak trees and the level field.

Photo 6. View of field looking west toward the library, showing mature oak trees and the level field.

To the east of the library a transect of tests was excavated between two parallel sidewalks (Photo 6). Included in the transect were Tests 111 to 115, 117 and 120. Test 111 may have been excavated in an old utility trench as a single layer of soil was encountered to 66 cm. The test was terminated at very compacted soils which could not be penetrated by hand. Test 112 appears to have been located on top of a former sidewalk as it terminated on a compacted level of gravel and sand at 19 cm.

To confirm that the material was recovered from a disturbed context four additional shovel tests (143-146) were excavated at the cardinal directions at 2.5 meters from Test 113 (Photo 6). Tests 143 encounter a buried utility trench as demarked by a caution tape found at a depth of 38 cm below the surface. This may be buried cable and telecommunication cables. Test 144 also encountered a utility trench in the northern half of the test. In the southern half, the three strata were encountered. The upper stratum appeared to be modern topsoil, the middle strata fill deposits, and immediately below appeared to be undisturbed sterile subsoil with glacial silt and gravel (40 cm below surface). The utility trench cut through all three strata suggesting it was of very recent origin. The trench fill was a uniform sand and silt, with gravel fill, likely brought in from off the property.

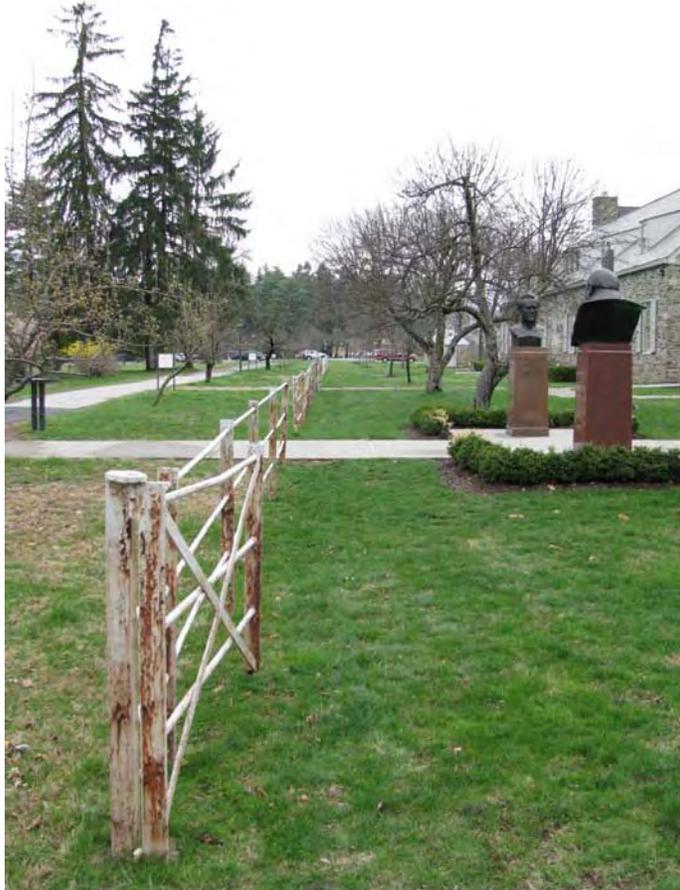
Photo 7. View of project area west of the library building, looking north, showing the relatively level terrain, fence, rows of trees and placement of concrete sidewalks.

Photo 7. View of project area west of the library building, looking north, showing the relatively level terrain, fence, rows of trees and placement of concrete sidewalks.

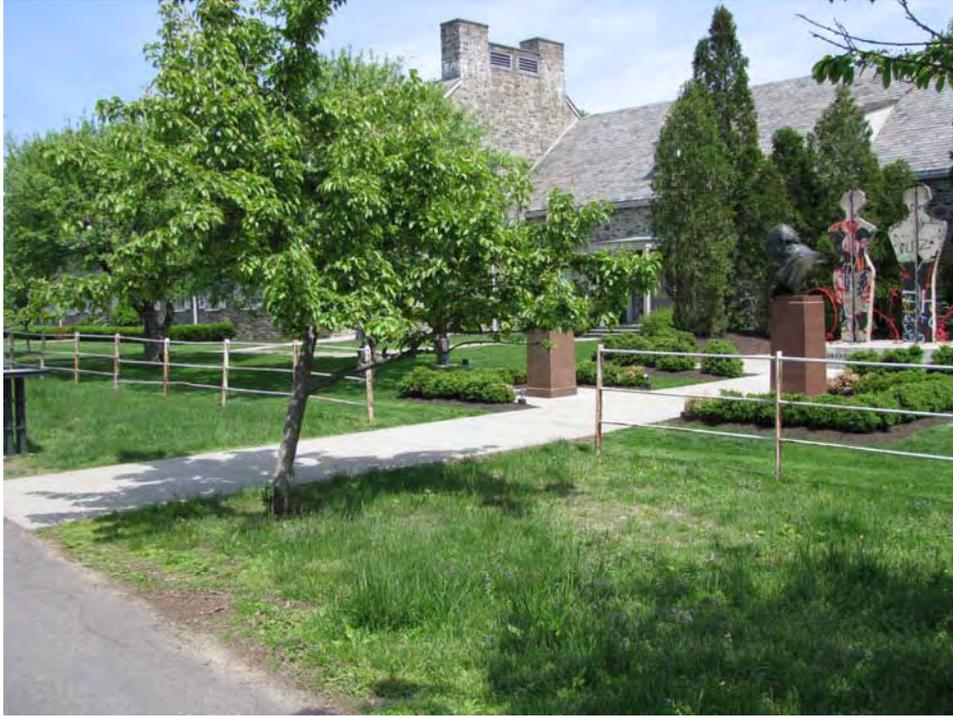
Photo 8. View of landscaped courtyard with sculptures, looking northeast.

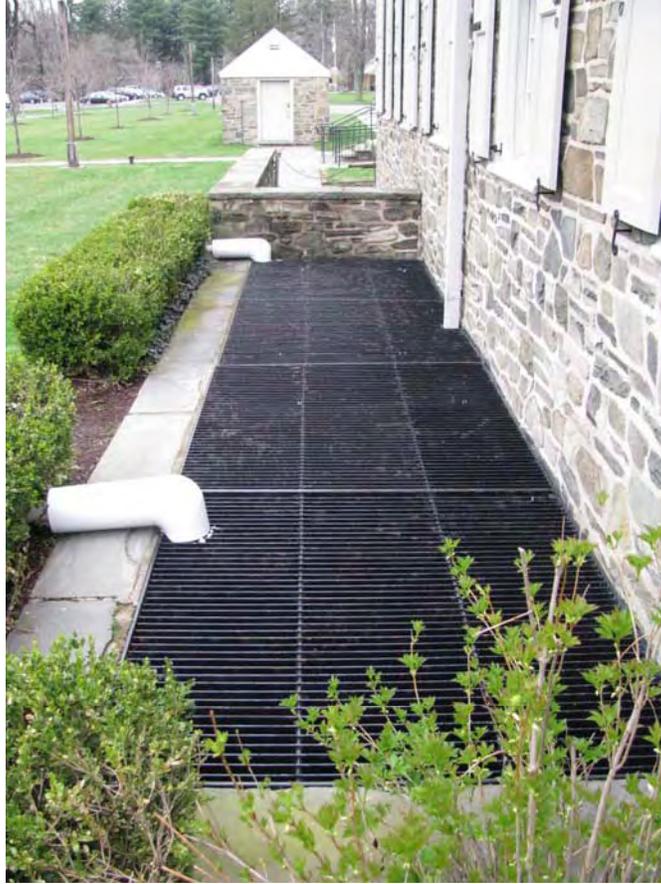
Photo 9. View of grated area along west side of library, looking north.

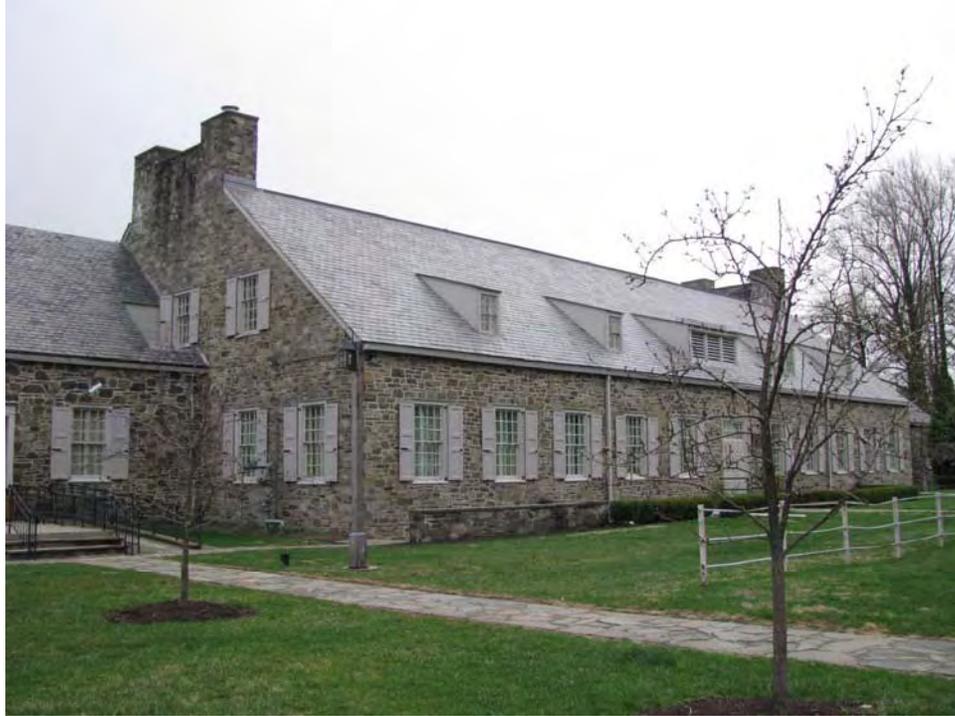
Photo 10. View of main library building looking southeast, showing where the gas service enters the building.

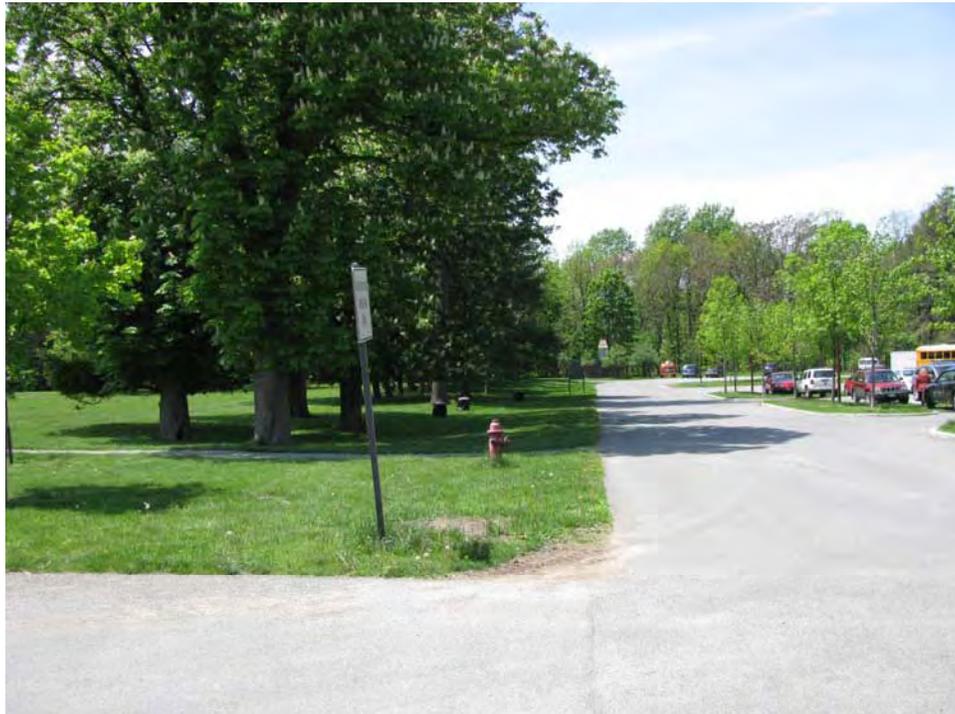
Photo 11. View of corridor that extends along the south side of the visitor's center parking lot, looking west, with existing cooling towers visible in the center of the photo just beyond the western edge of the parking lot.

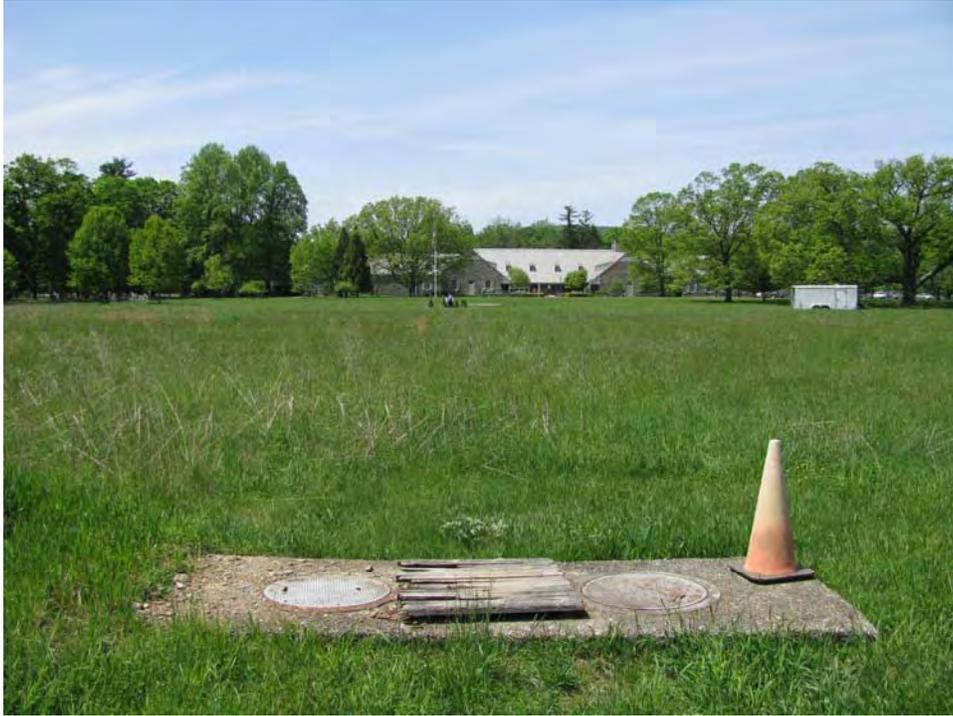
Photo 14. View of field looking west, showing utility pad.

lines whose presence is evident by the placement of fire hydrants (Photos 13). A relatively level open field east of the library is traversed by existing utility lines, including gas, electric and water (Photos 14). An additional portion of the project area is located west of the library building in the wooded section of the property. It appears that the intermittent seasonal stream that was shown on historic maps has been buried in a culvert where it crosses the property and has been diverted down a sloping carriage road to an outlet beneath the bluff (Photo 15). It may also serve as a storm sewer to move water away from the building. Multiple catchment basins are located on either side of the road as it navigates down the slope (Photo 16).

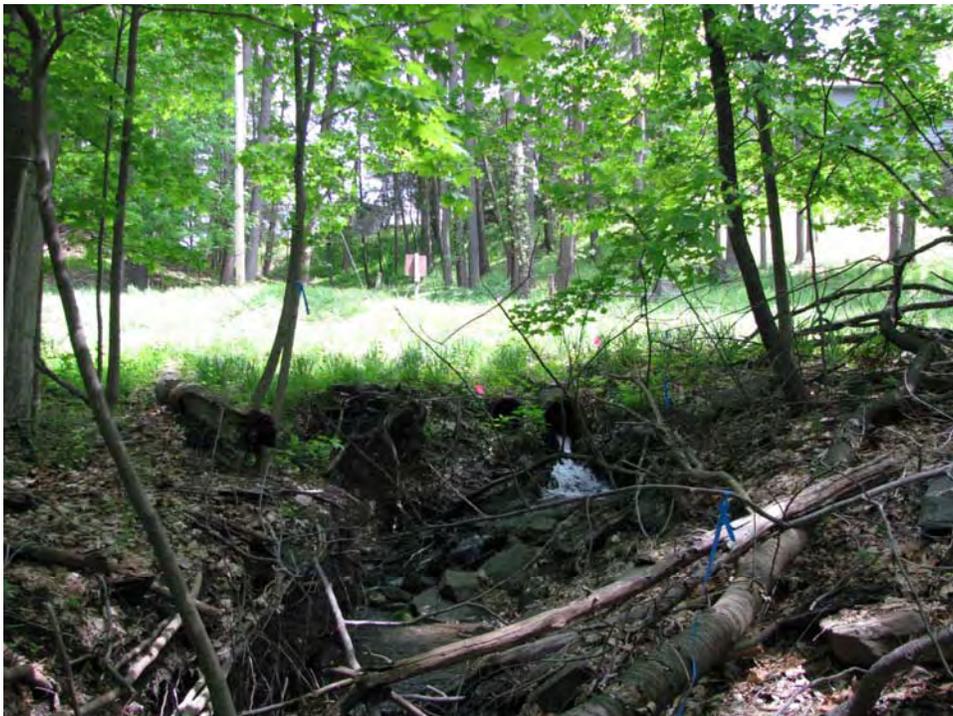
Photo 15. View of outlet of storm sewer/intermittent stream, looking north-northeast, showing wooded area and slope up to top of terrace where main buildings are situated.

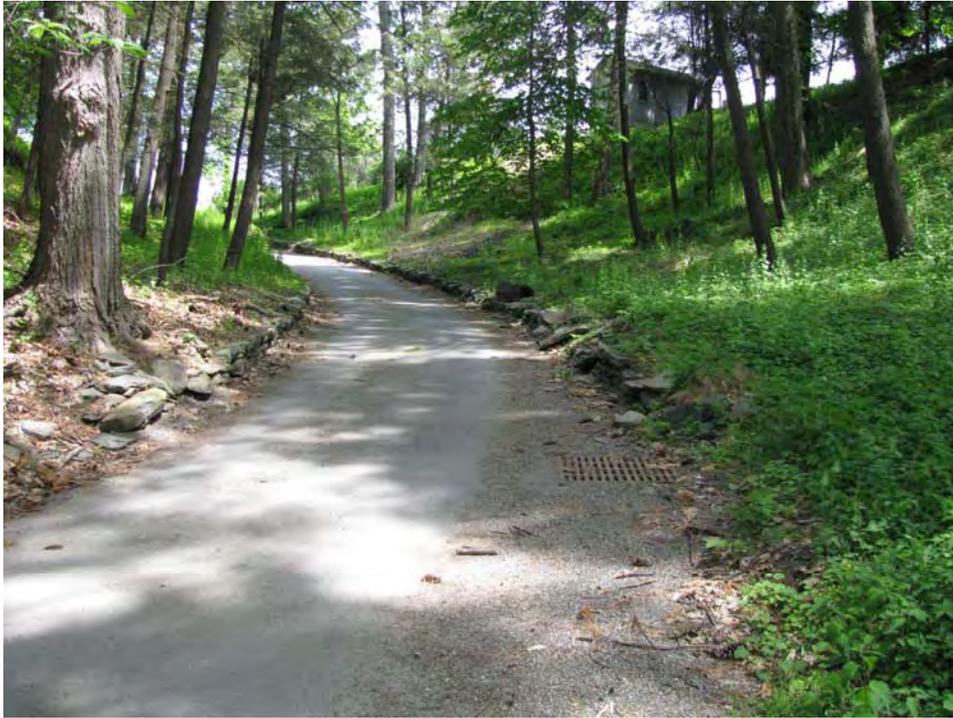
Photo 16. General view of carriage road showing slope and catchment basins, looking northeast.

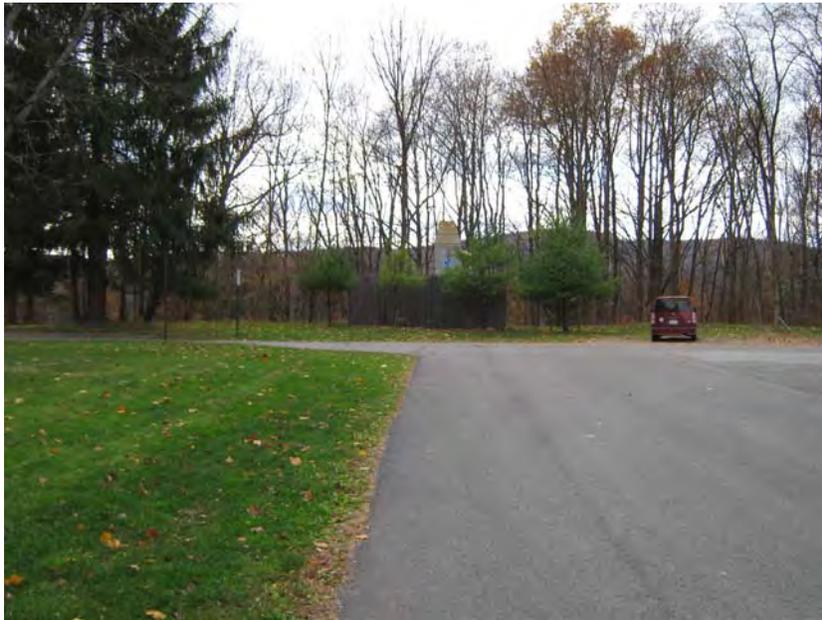
Photo 1. View west of the exiting cooling tower for the Wallace Center. The library will abandon its existing cooling tower and utilize the visitor's center. The area along the southern portion of the parking lot where the proposed heating and cooling lines will be buried has been previously tested (see Figure 3).
