Final Environmental Assessment

**Franklin D. Roosevelt
Presidential Library and Museum
Renovation Project
Hyde Park, New York**

April 2010

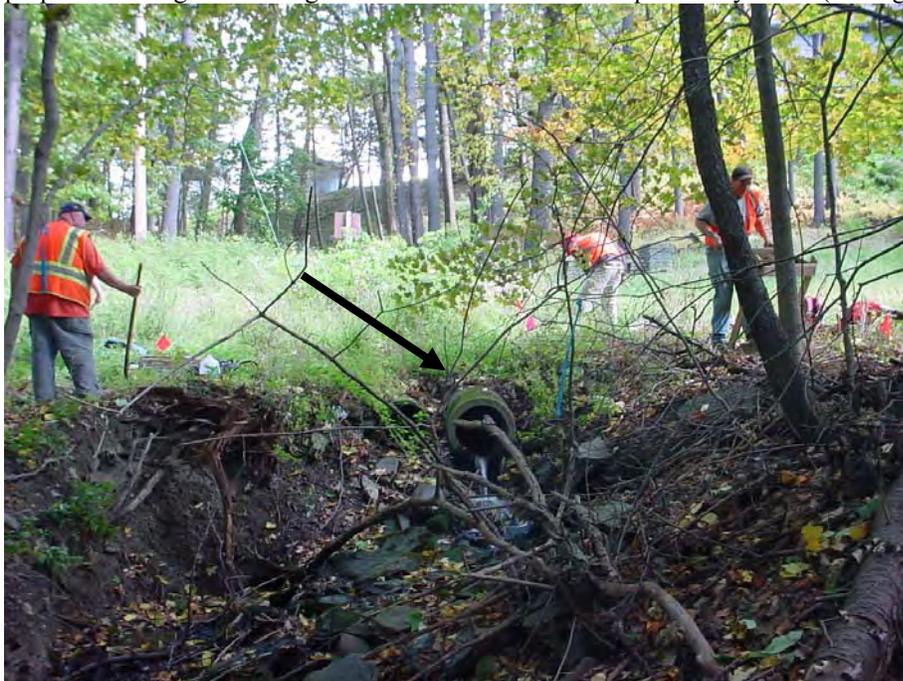
Photo 2. The storm water outlet location on the NPS property to the west of the library. Seven tests (202-208) were excavated around the outlet. The stream banks are being eroded by the flow of water. The area immediately adjacent to the outlet has been disturbed by the installation of several generations of drainage pipes (indicated by arrow).

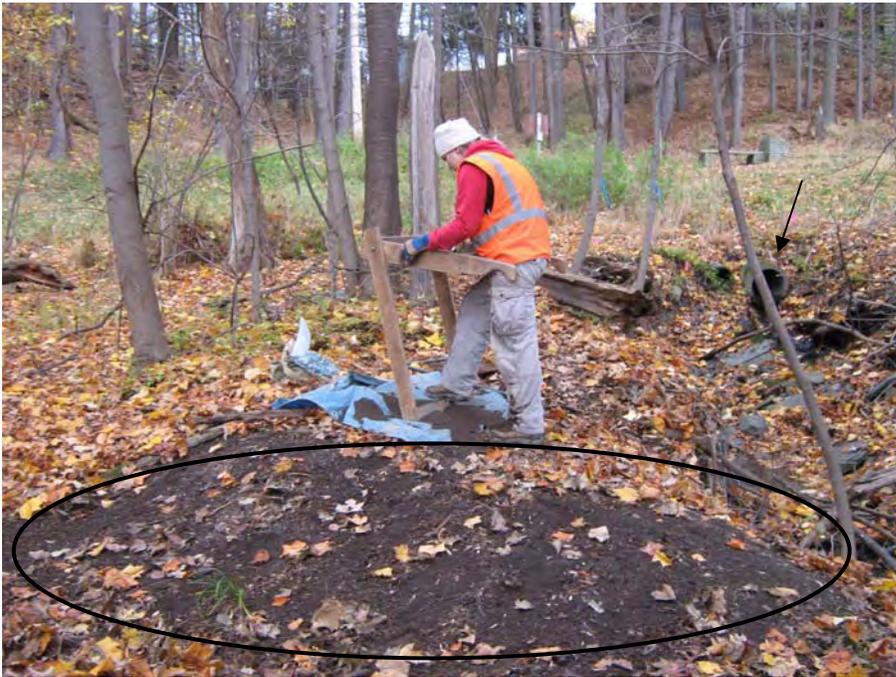
Photo 3. A 20th-century coal ash dump along side the small stream into which the storm water outlet (see arrow) from the library flows. Test 206 was excavated on the east side of the dump, and helped to delineate its eastern extent. Avoidance of the dump is recommended as it is likely a National Register eligible resource, associated with the Roosevelt family.

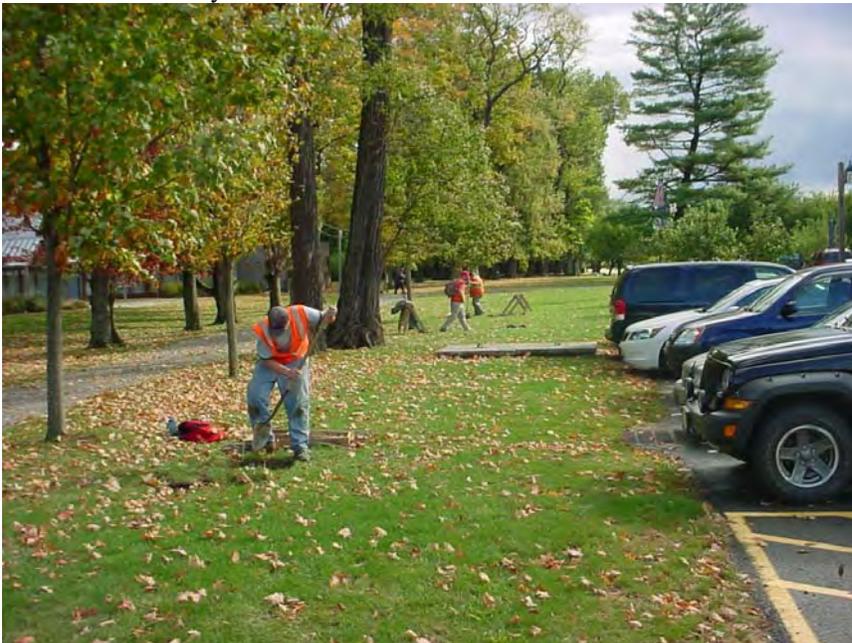
Photo 4. View east along the northern border of the library property (NARA), the employee parking area is to the right and the new Wallace Center to the left. Test 105 is being excavated by an archeologist in the foreground, to the rear the top a buried concrete electrical vault can be seen.

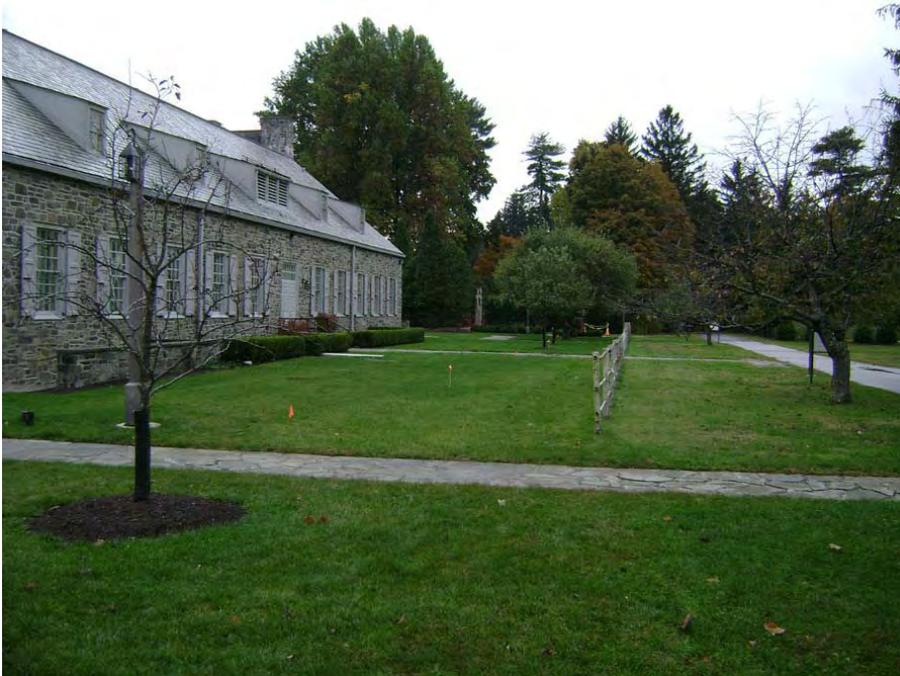
Photo 9. Archeologists excavating tests along the southern end of the library. Test 138 is in the foreground and Test 137 in the rear.

The southwest side of the building, near the current sculpture garden, appears to have been less disturbed than other areas around the library. Test 134 to 138 all ended in natural subsoil at a depth of about 30 to 50 cm (Photo 9). Only one of the tests located an artifact. A cut iron nail was located in Level 1 of test 135.

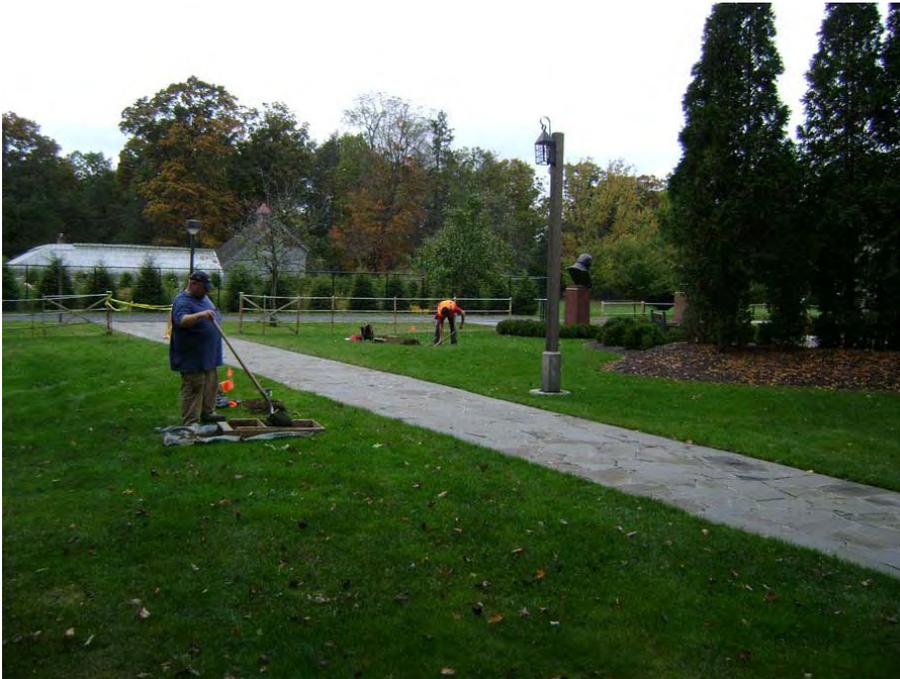
Photo 10. View southwest of the former sunken courtyard at the library. Most of the courtyard was filled in for the library additions built in 1971. The courtyard was artificial and constructed by excavating the south end of the original library.

A short transect of tests were excavated along the southeast part of the library, in what was once part of the sunken court or garden (Photo 10). Tests 141 and 142 did not encountered subsoil, as it was likely fill brought in later to level out the former sunken garden. The proposed impacts to the area include a new storm water drain and the replacement of drains around the perimeter of the foundation.

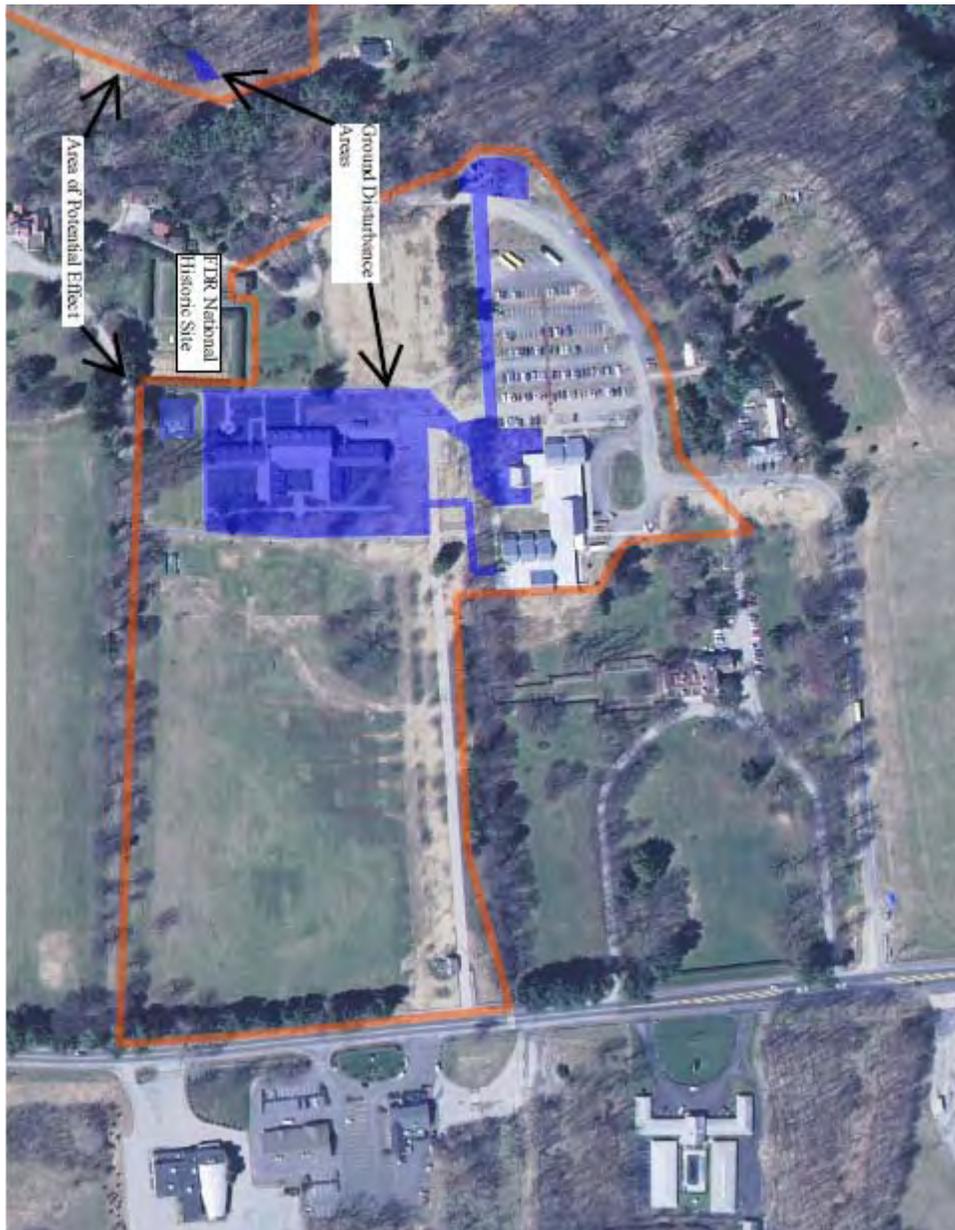
Figure 1. A summary of the area of potential effects (APE) and the proposed ground disturbing areas for the FDR library improvement project.

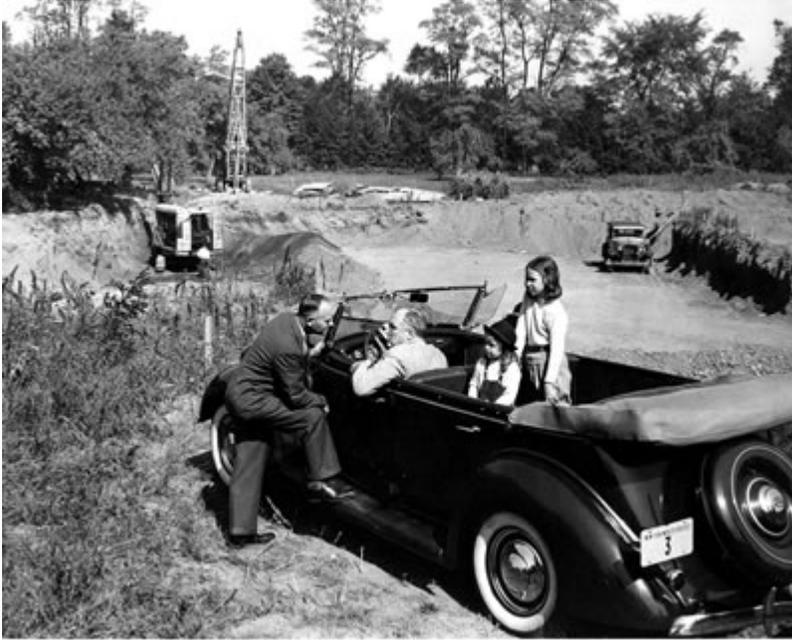
Figure 2. A circa 1939 view of the construction of the Presidential Library, as supervised by Franklin Roosevelt. Note the truck in the excavation for what would become the cellar of the library. The view is to the northwest. The archeology revealed widespread disturbances around the library from initial construction, later additions and upgrades to the library (<http://docs.fdrlibrary.marist.edu/frdcsb10.html>).

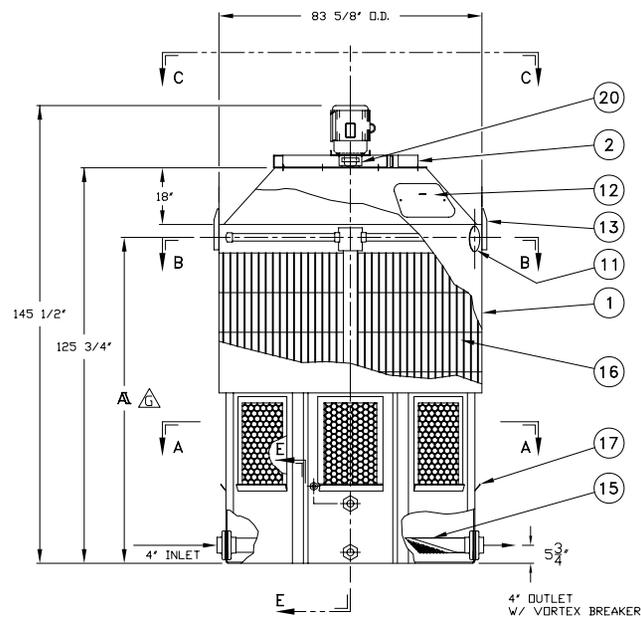
ELEVATION

- NOTES:
- DIMENSIONS SHOWN ARE NOMINAL AND ARE SUBJECT TO FABRICATION TOLERANCES.
 - TOWER TO BE INSTALLED ON A FLAT AND RIGID SURFACE, PROPERLY SUPPORTED.
 - EXTERNAL PIPING MUST BE INDEPENDENTLY SUPPORTED.
 - PIPING AND BULKHEAD FITTING MATERIAL IS PVC.
 - HARDWARE MATERIAL IS TYPE 304 STAINLESS STEEL.
 - FAN ASSEMBLY SHIPPED SEPARATELY FROM THE TOWER FOR FIELD INSTALLATION.
 - FOR BOTTOM OUTLET MAXIMUM OPENING IN SUPPORT TO BE 14" x 14".
 - MAXIMUM INLET WATER TEMPERATURE 140°F. (CONSULT FACTORY FOR HIGHER TEMP. APPLICATIONS.)
 - SEE DWG NO. DT-D-81-755 FOR MULTICELL LAYOUT.
 - ALL DIMENSIONS ARE IN INCHES.
 - ALL WEIGHTS ARE IN POUNDS. DRY WT. INCLUDES; FAN ASSEMBLY, SINGLE SPEED MOTOR & TOWER COMPLETE. MAX. FAN WT. INCLUDES FAN ASSEMBLY AND TWO SPEED MOTOR.
 - RISER PIPE HAS 1/4" WEEP HOLE IN SUMP.

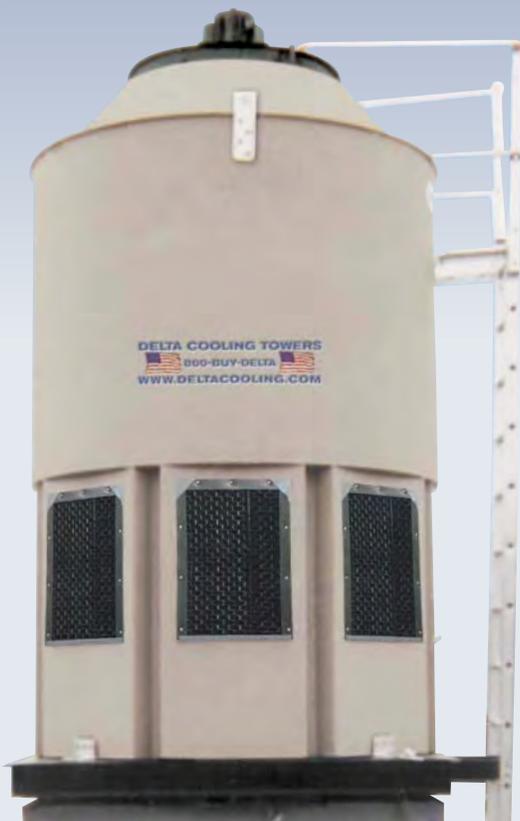
are induced draft counter flow design cooling towers with single module capacities from 100 to 250 cooling tons. These towers are a unitary seamless engineered plastic design that Delta has been manufacturing since 1981 providing long-term durability and trouble-free operation.
